Development of Nonlinear Harmonic Sensors for Detection of Mechanical Damage

DE-FC26-01NT41156

Presented by
Southwest Research Institute
(Co-funding by Tuboscope Varco Inc.)

Presented at
NETL Industry Forum
Morgantown, WV September 17, 2002

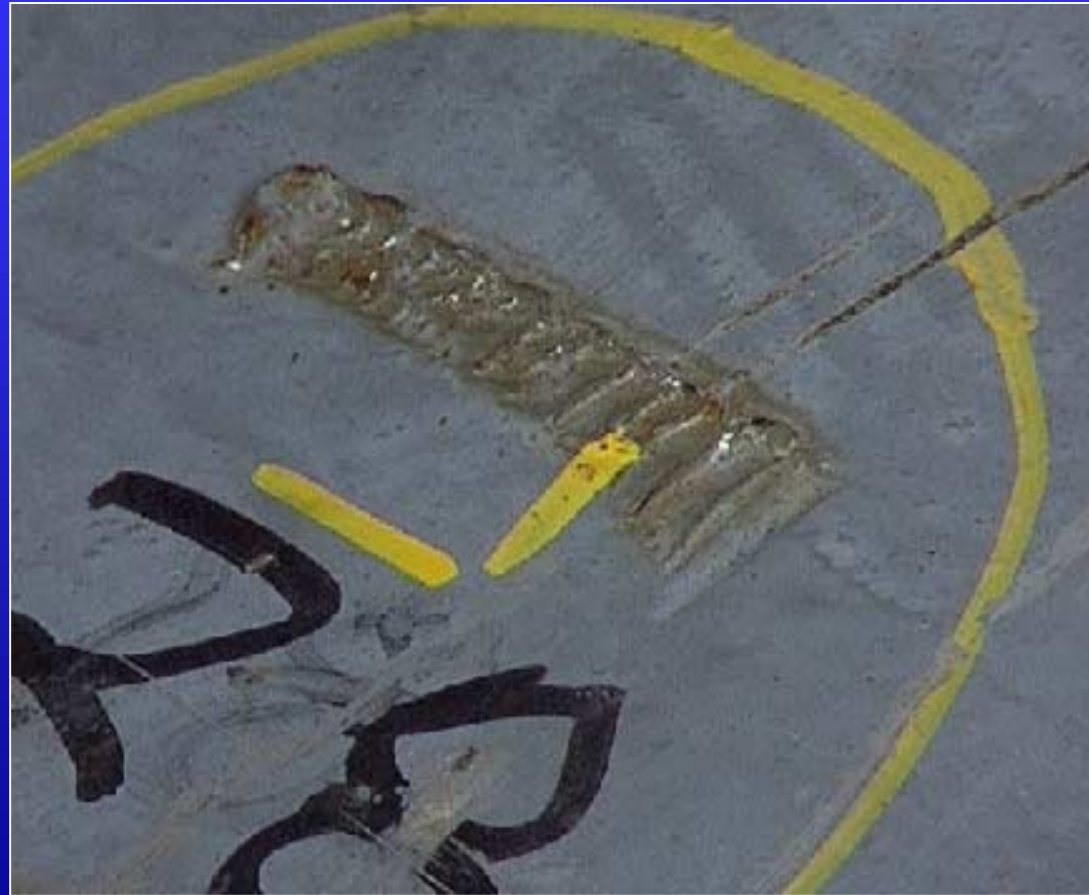
Gouge Without Dent

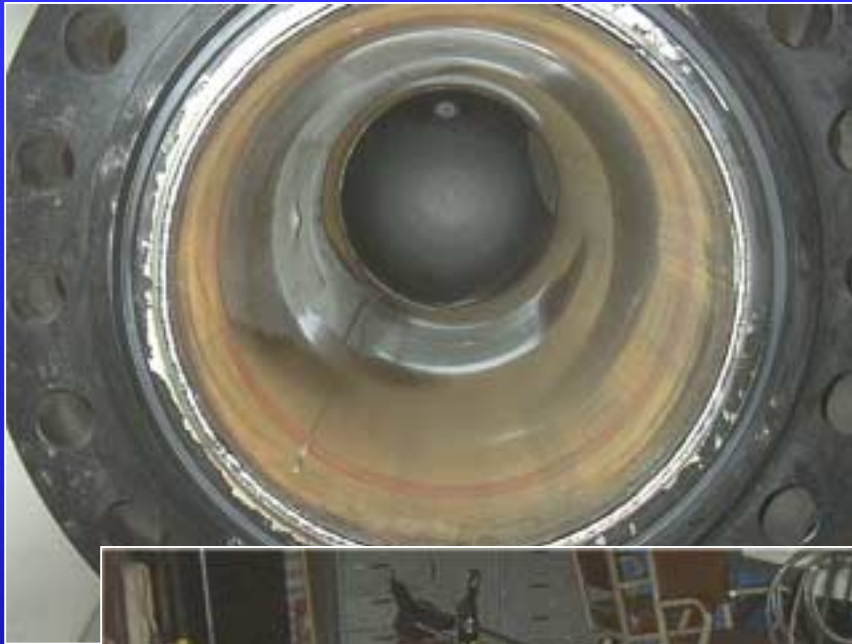
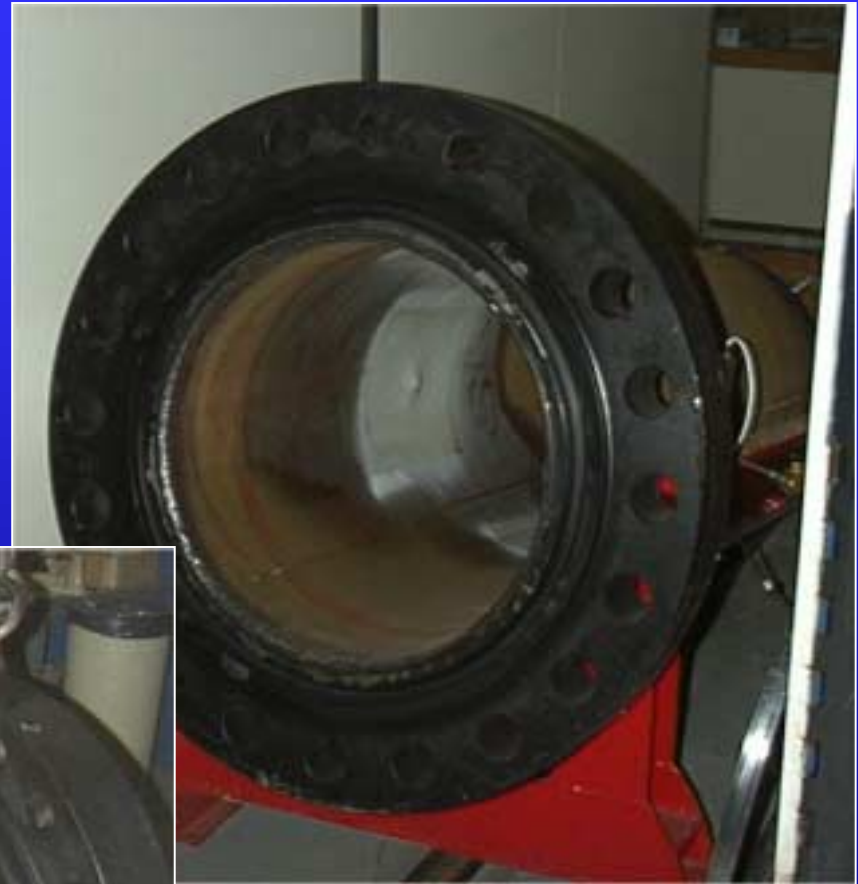
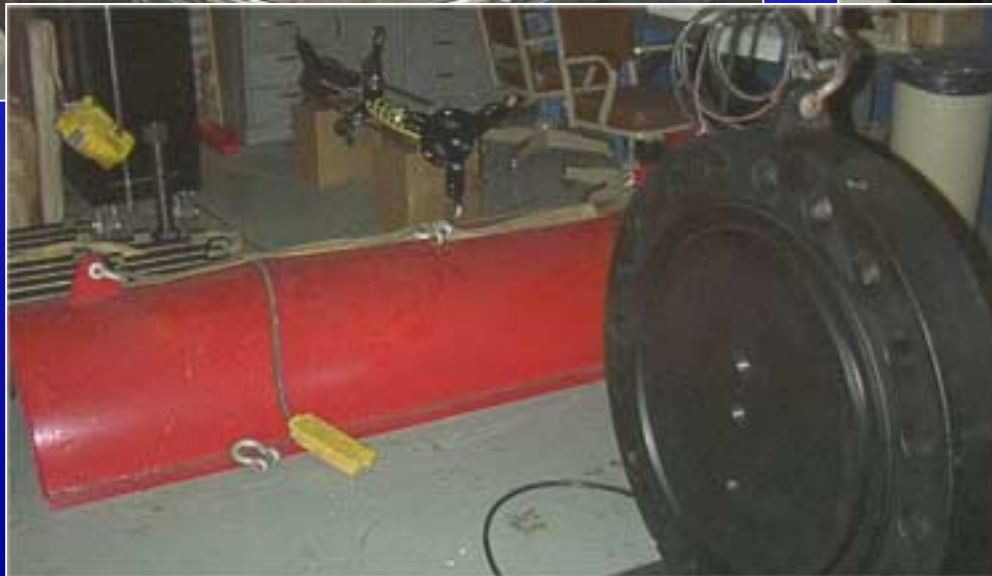
NLH Testing Set-Up

- Measure NLH response to dents/gouges of various severities
 - No pressure
 - Pressure
- Data taken as probe is scanned in raster pattern by mechanized scanner

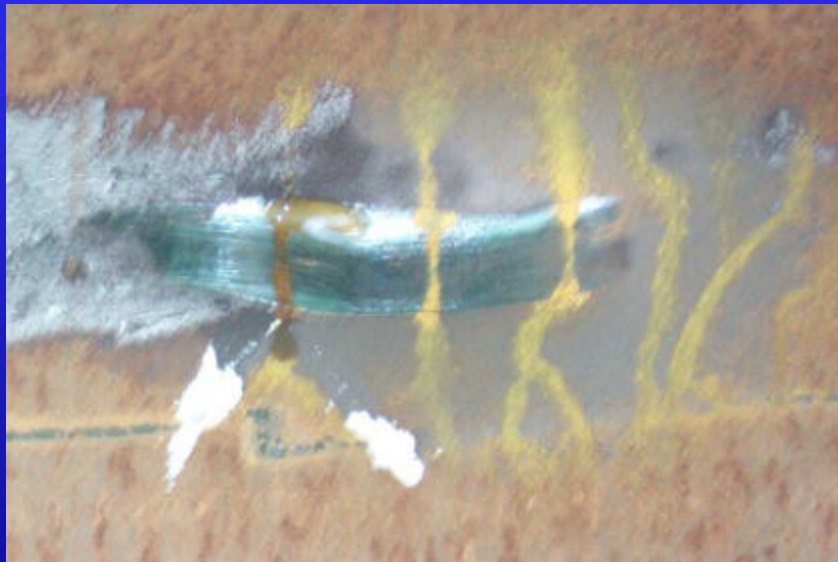
Typical Defect (5C)

➤ Photo (O.D.)

- 18 Defects
- Dent depths from 0.12 to 0.96 inch before re-rounding from internal pressure
- Gouge Lengths from 0 to 6 inch
- Width of tool: 0.33, 0.5, 0.75 inch
